### Site 182 Lower Days Pond

Great Marsh Coastal Wetlands Restoration Plan  
Rapid Technical Assessment Site 182

## Site 182: Lower Days Pond, Gloucester, MA

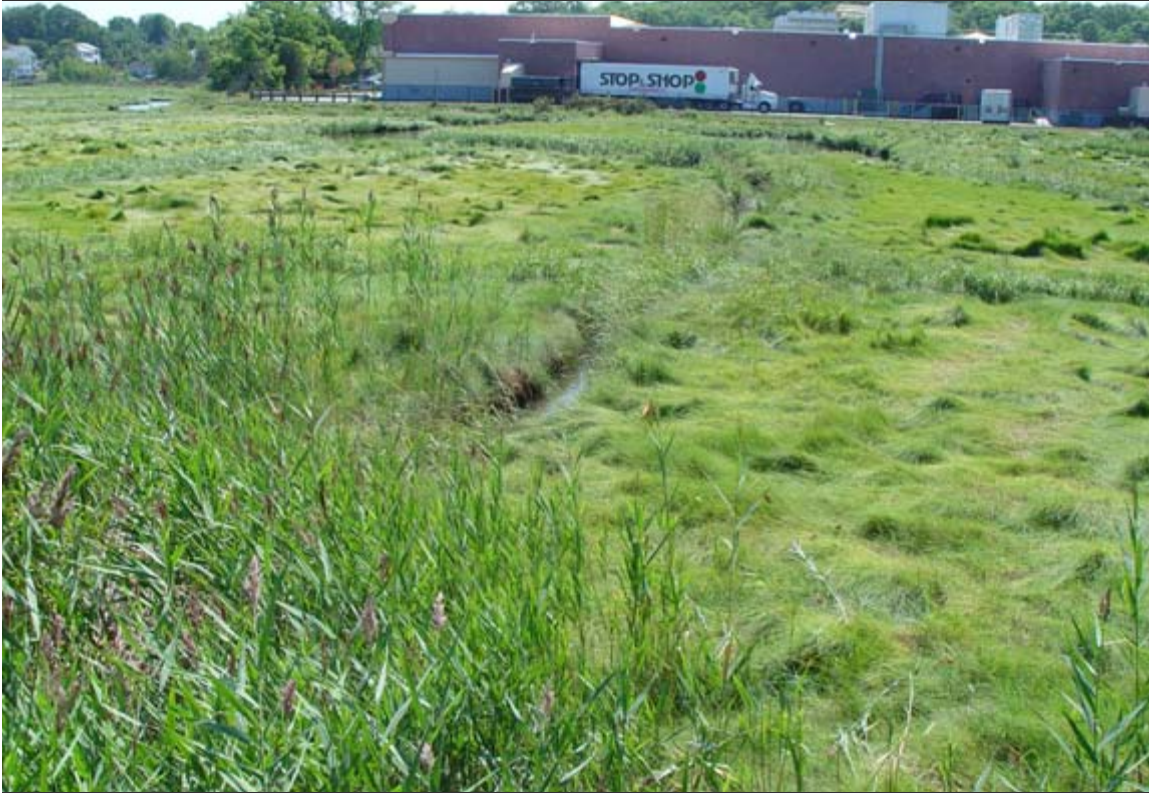
**Photo 1 - Salt Marsh Downstream of Berm**

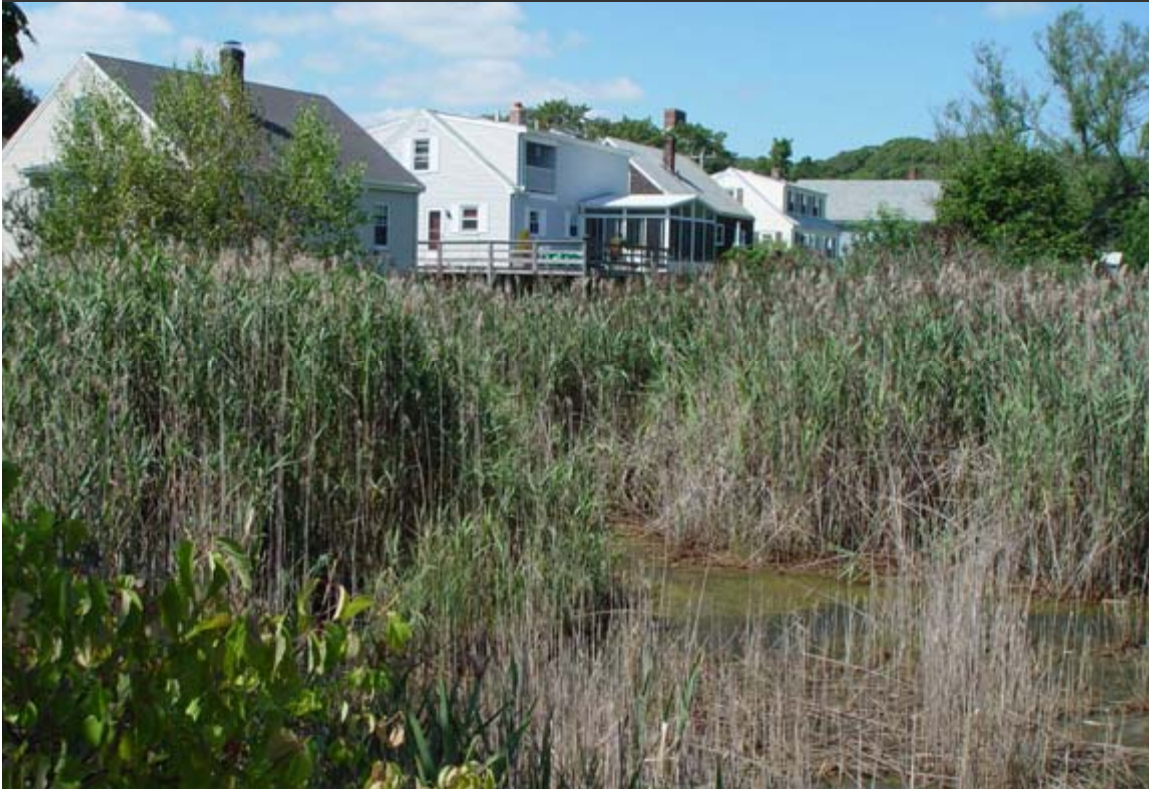
**Photo 2 - Properties along Abbott Road Abutting Site**

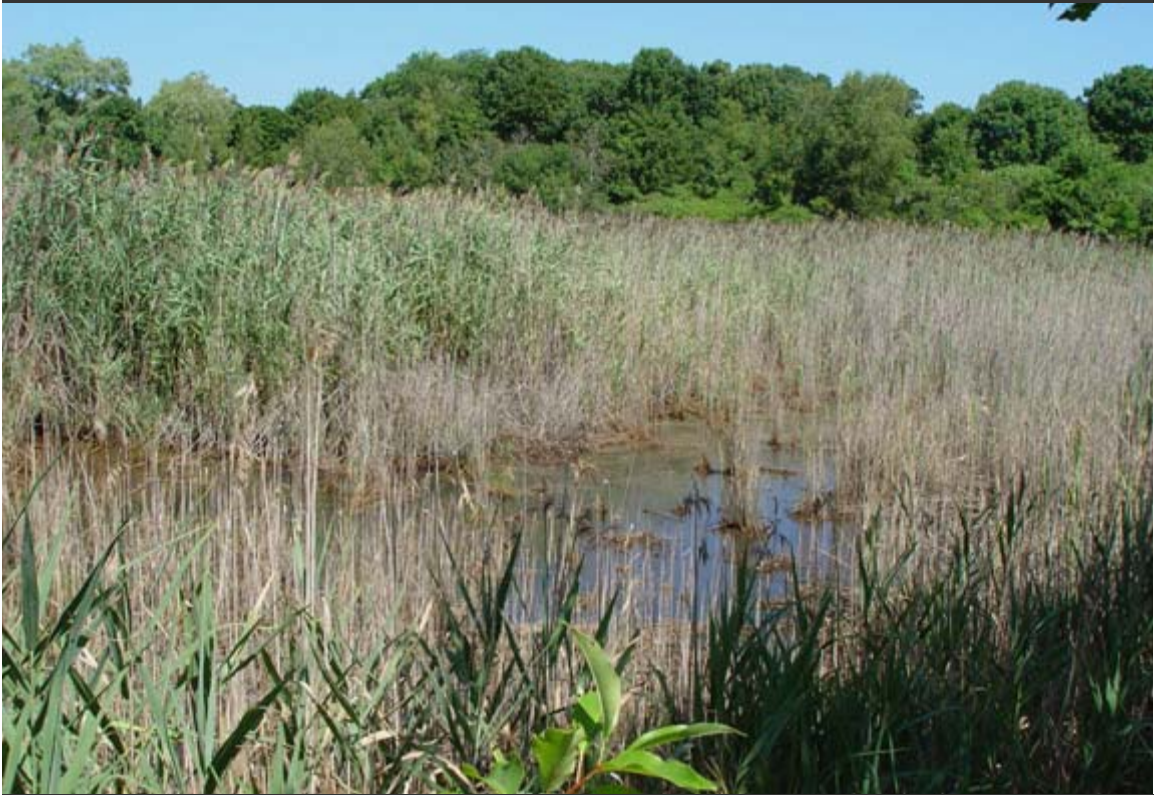
**Photo 3 - Upstream View of Site from Berm**

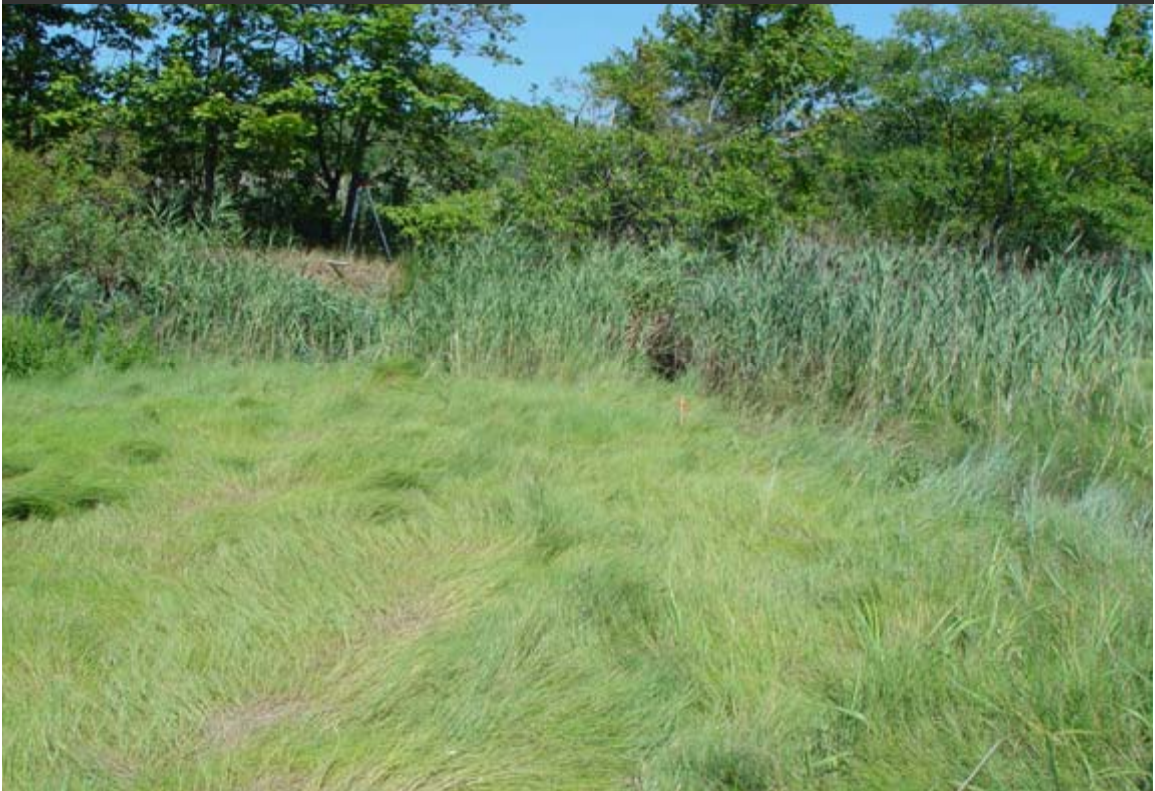
**Structure conditions:** An earthen berm separates Lower Day's Pond from the adjacent salt marsh downstream. Tidal flow from a small creek is conveyed into the site via a 12 in cast iron culvert. Stone placed upstream of the culvert prevents the marsh from draining down to the elevation of the invert. The berm is well-vegetated. There is some minor erosion around the culvert, but overall the berm and culvert are in good condition.

**Photo 4 - Downstream View of Berm**

To improve tidal flow at the potential restoration site, the existing 12 in culvert will have to be replaced with a larger (approximately 60 in) pipe or box culvert. Due to the presence of low-lying abutters it is assumed that breaching or removing the existing berm is not a feasible option. In addition to installing a larger culvert, restoration work will have to be performed in the site to remove *Phragmites* stands and accumulated sediment (approximately 7,000 cubic yds), stabilize existing stormwater outfall locations, and create a series of drainage channels. The total construction cost associated with is project is estimated to be \$450,000. This estimate does not include end-of-pipe structural BMPs.

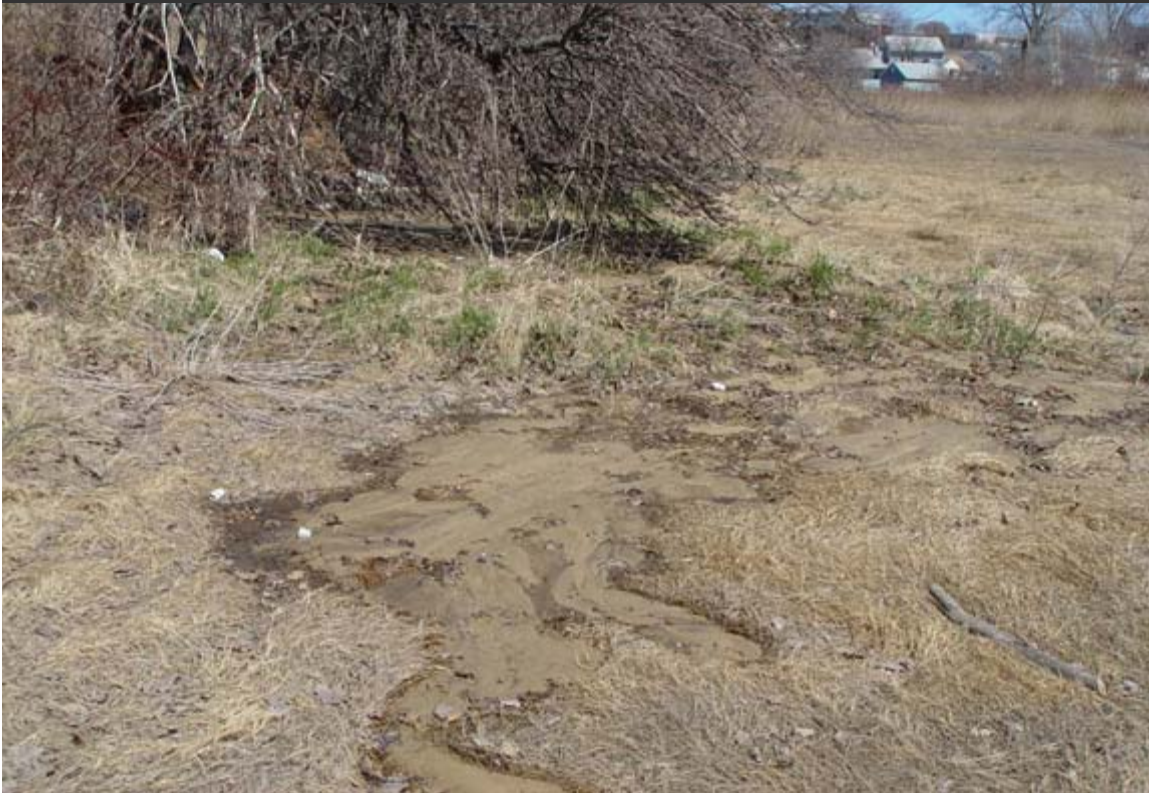
**Photo 5 - Sediment from Abbott Road**

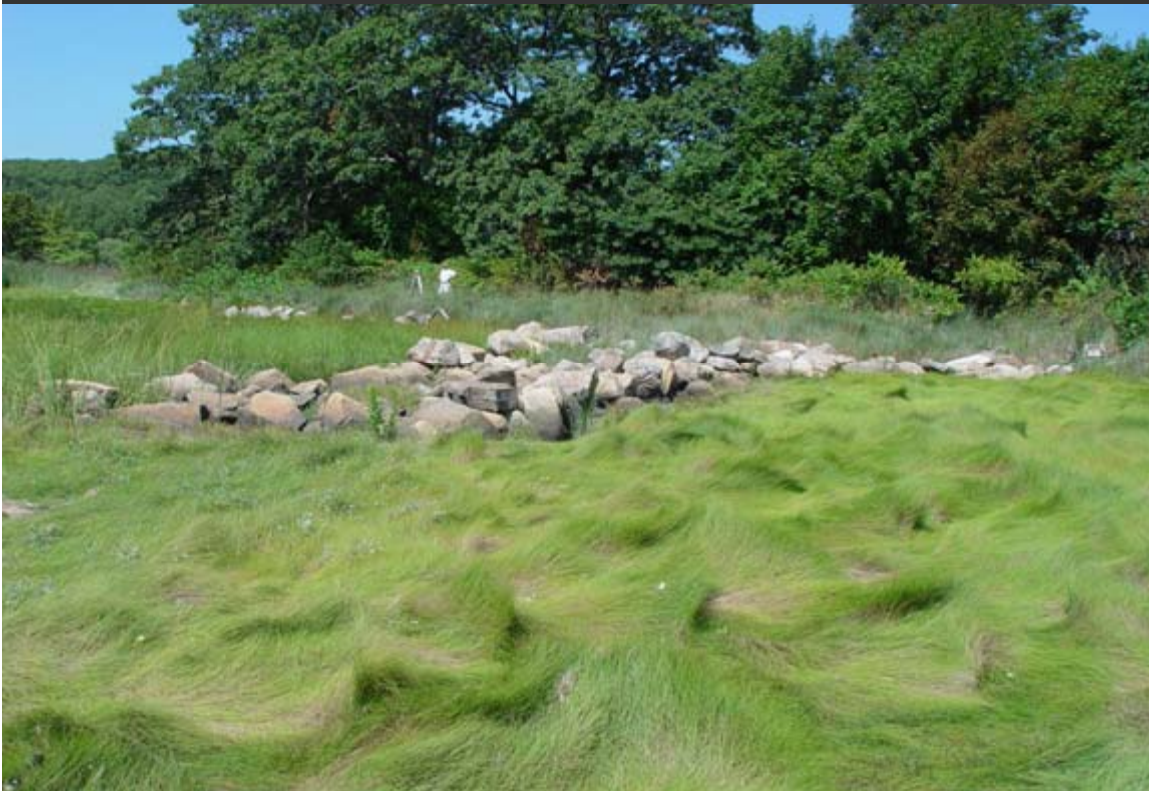
Berger also investigated a small area of historic fill on the salt marsh approximately 400 ft southwest of Lower Days Pond. The area largely consists of a narrow linear area of fill extending from the edge of the upland to the edge of the creek. The fill is comprised entirely of large stone varying in diameter from approximately 1 to 3 ft. The area of stone fill is approximately 75 ft in length and 18 ft in width. The depth of the stone fill is approximately 4 ft near the upland edge and tapering to the existing marsh elevation. The site reportedly was the location of a small fishing wharf along a small embayment within the creek. There was no additional evidence of past structures (e.g., wooden piles) remaining in the area. The area has good construction access from the adjacent side street. The work would not impact any abutting properties or known utilities. The work could be accomplished without the need of dewatering. The site is privately held and would require the permission of the current land owner. A cost estimate of the removal of this stone fill would be in the range of \$10,000. This smaller scale project could be undertaken by the City or other private developer in need of mitigation credits.

**Photo 6 - Area of Stone Fill Viewing North**

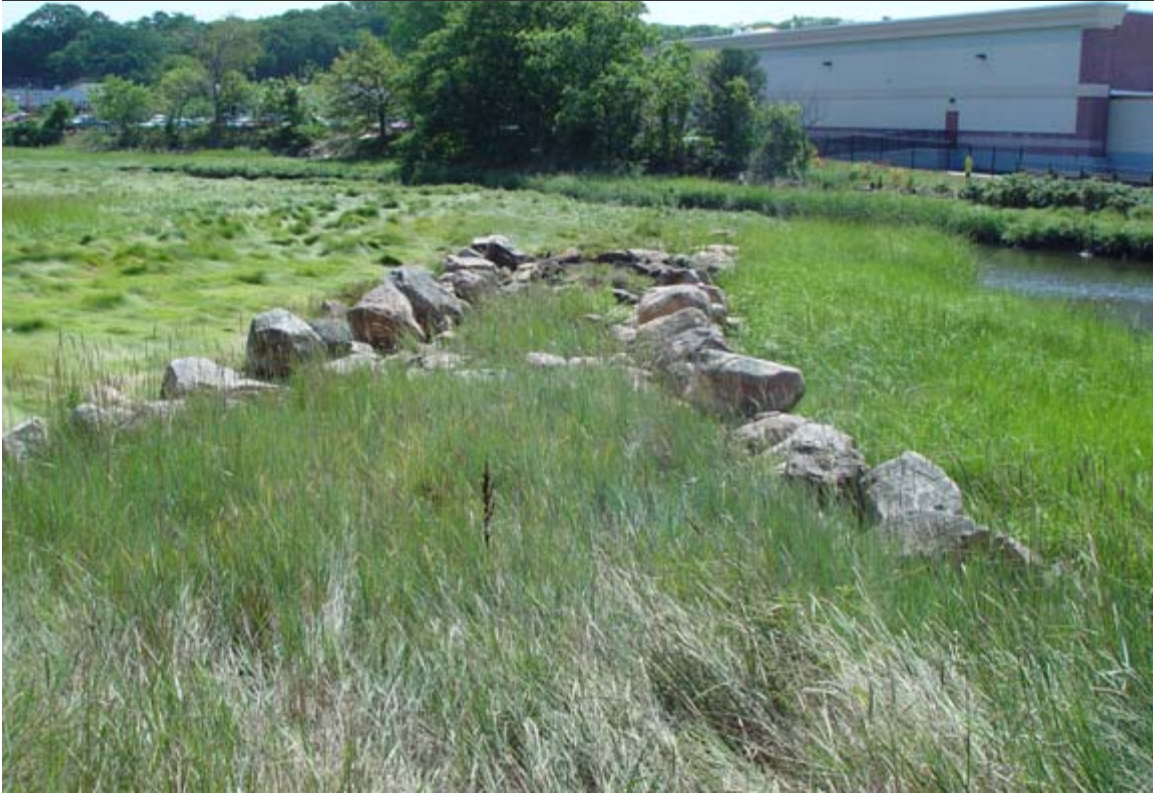
**Photo 7 - Area of Stone Fill Viewing South**

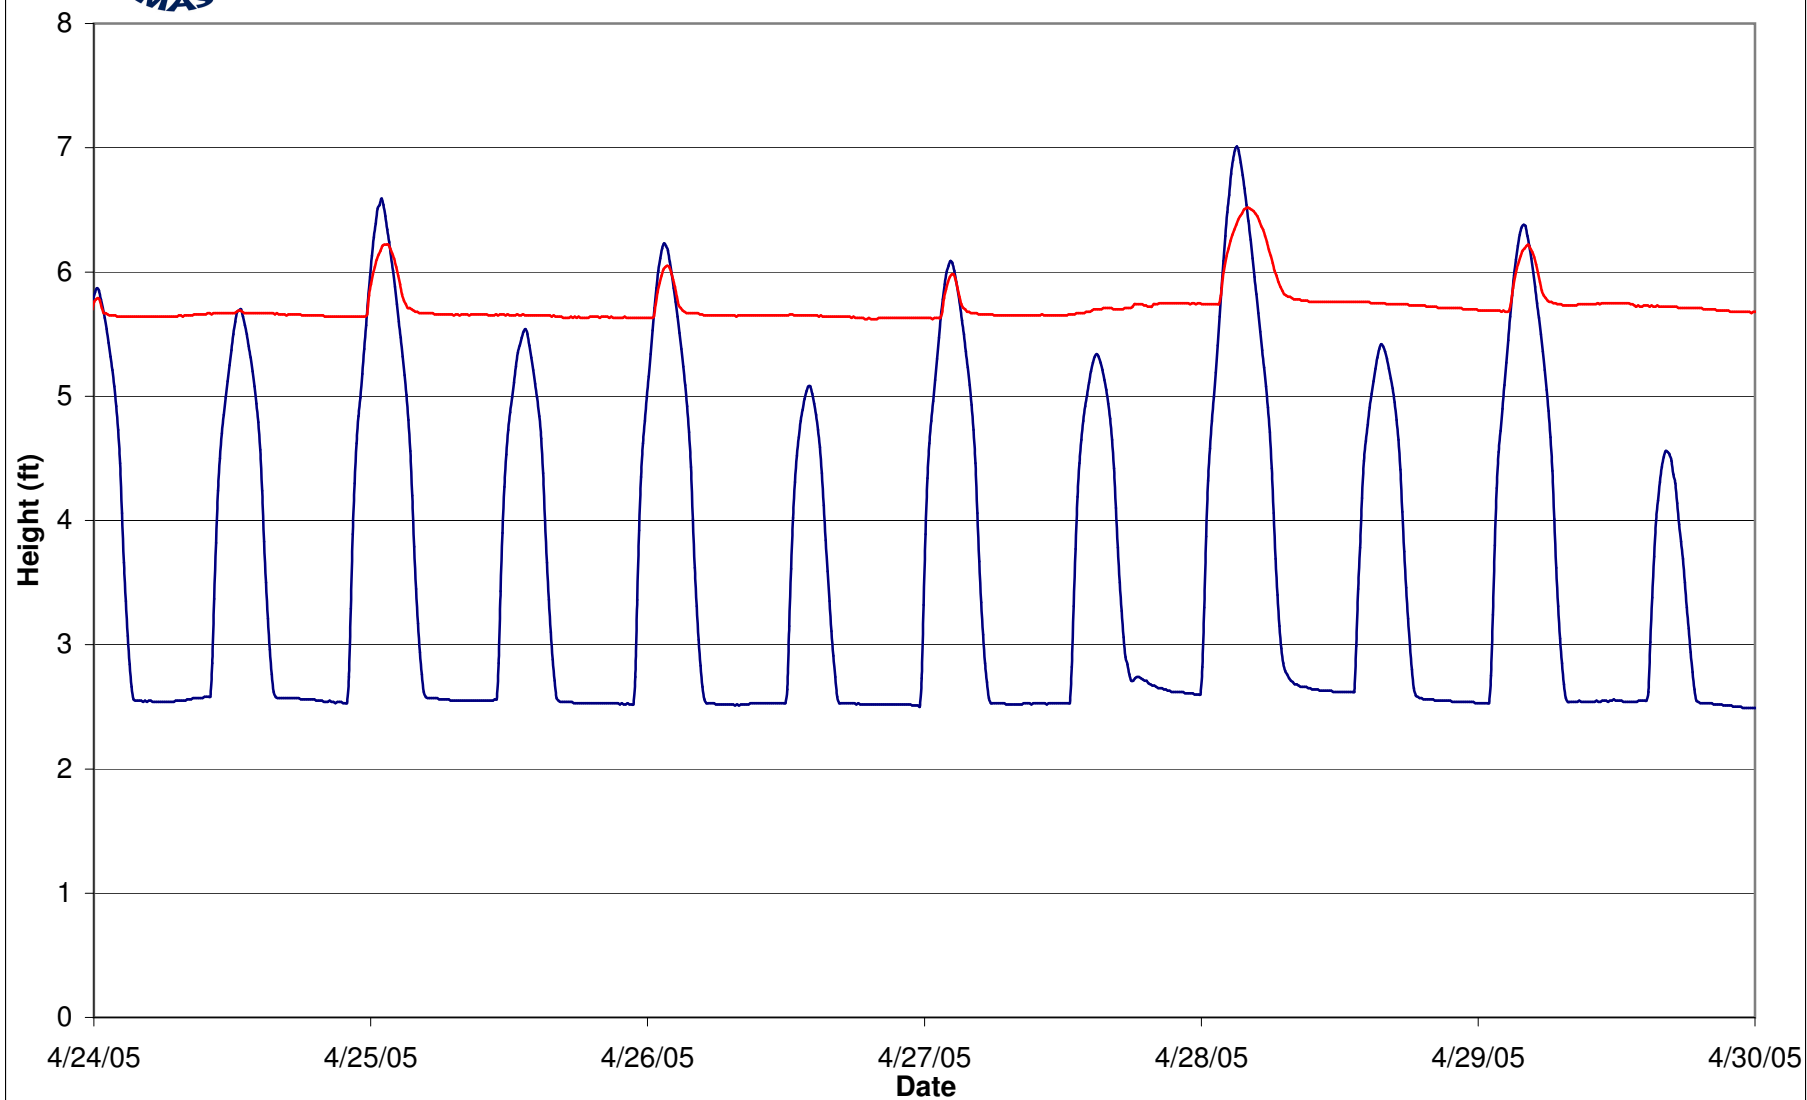
Tide gauges placed on either side of the berm and deployed between April 20 and May 2, 2005 documented a major reduction in tidal amplitude as well as a restriction in height during large spring tide events. The total tidal prism of the marsh creek downstream of the culvert is more than 4 ft. The tidal prism in Lower Day's Pond varies from 0 to approximately 0.9 ft. Stones placed near the upstream invert create a small impounded area. This factor along with the small pipe and substantial rainfall/stormwater contributions on both the 24<sup>th</sup> and 28<sup>th</sup>, caused the site to maintain a standing water depth of approximately 6 in during the period of the gauge deployment. There were a total of 23 tidal cycles recorded downstream of the culvert during the deployment period. The gauge upstream of the culvert recorded a tidal prism on only 8 of the 23 tidal cycles, when the tide height downstream was 5.68 ft NAVD or higher. The highest tide downstream of the culvert was recorded on April 28 at 3:06 AM. The NAVD adjusted height was 7.01 ft. The upstream adjusted height was 6.52 ft. and occurred at 4:02 AM.

The restriction caused a tidal dampening of 0.49 ft upstream of the culvert and a delay of 56 minutes. The dampening amounted to approximately 11.1% of the total tidal prism recorded at the downstream gauge. Measured salinities recorded during slack ebb tide were 0.4 ppt upstream and 0.2 ppt downstream of the culvert. These values are indicative of significant freshwater contributions to the marsh system, especially during spring tide conditions. Tidal flow into Lower Day's Pond occurs during approximately 1/3 of tidal cycles in the adjacent marsh system. When tidal heights are high enough to cause flow into the pond, there is both a dampening and delay of tidal flow into the restoration area. If the ground elevations upstream of the berm were more comparable to the downstream marsh, a greater restriction in tide heights would be anticipated.

Down Stream  
Up Stream
